Rocky Flats Environmental Technology Site

RECONNAISSANCE LEVEL CHARACTERIZATION REPORT (RLCR) SUPPLEMENT

BUILDING 771 CLOSURE PROJECT

REVISION 1

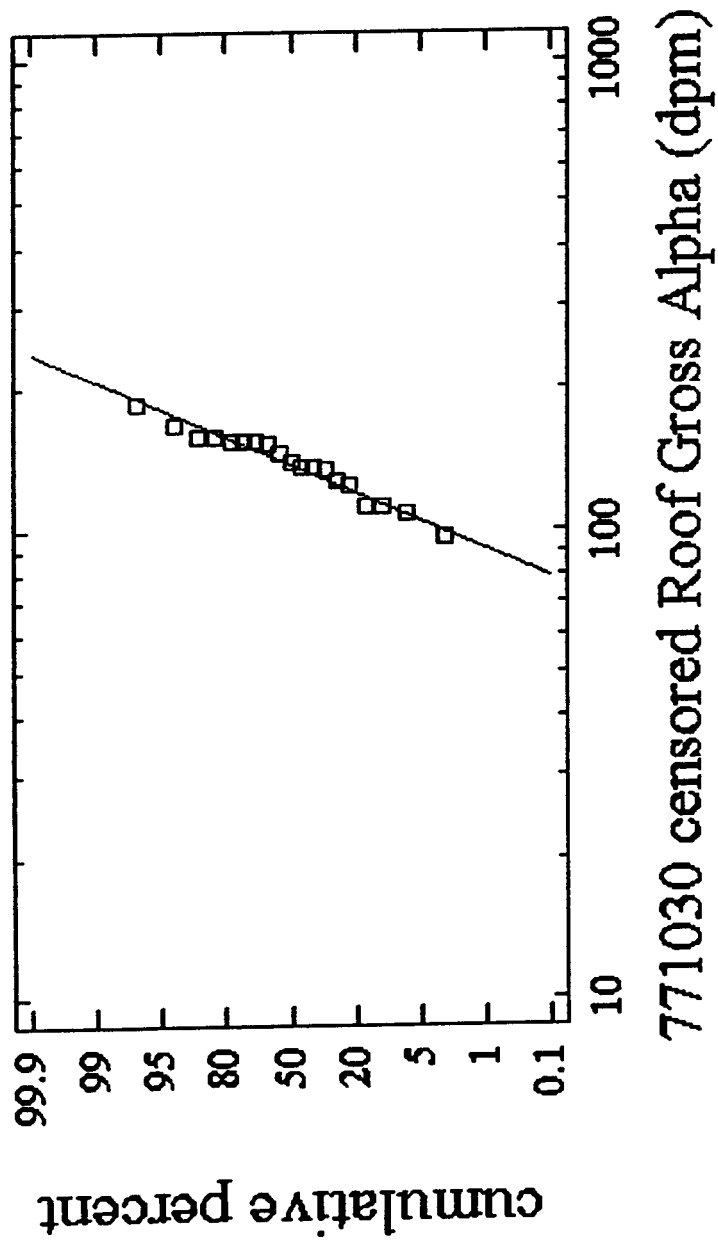
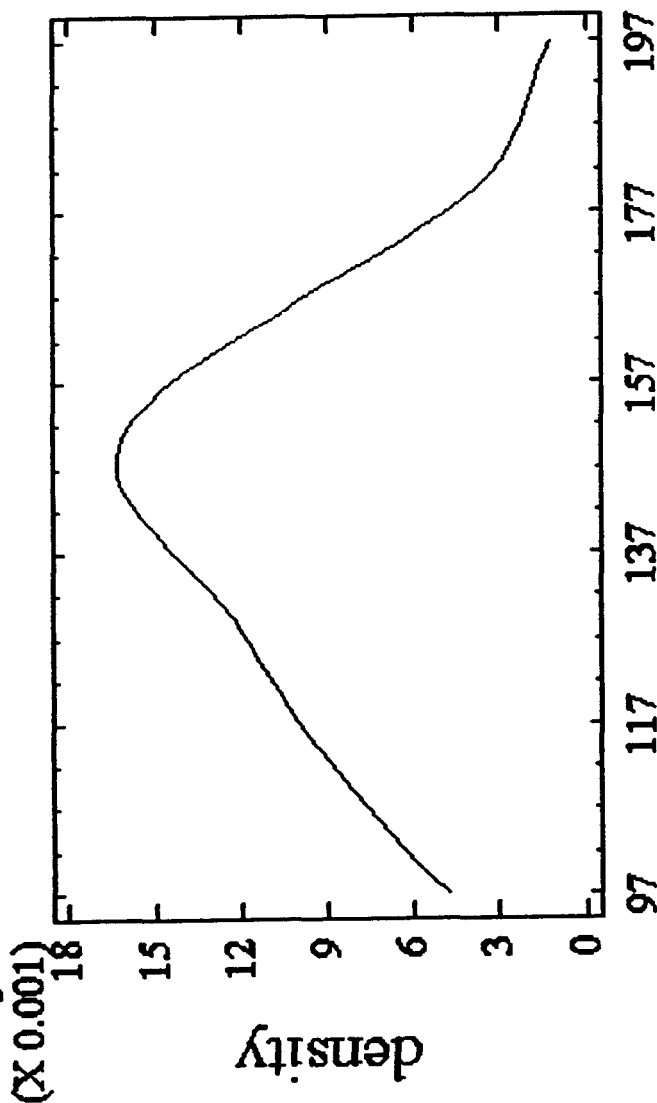
Lognormal Probability Plot

Since the smallest P-value amongst the tests performed is greater than or equal to 0.10, we can not reject the idea that 771030 Po210 Investigation comes from a lognormal distribution with 90+ or higher confidence.
